# Midwest Kiln Baghouse Rebuild

By Keith Gooch and Larry McConnell, CLARCOR industrial Air

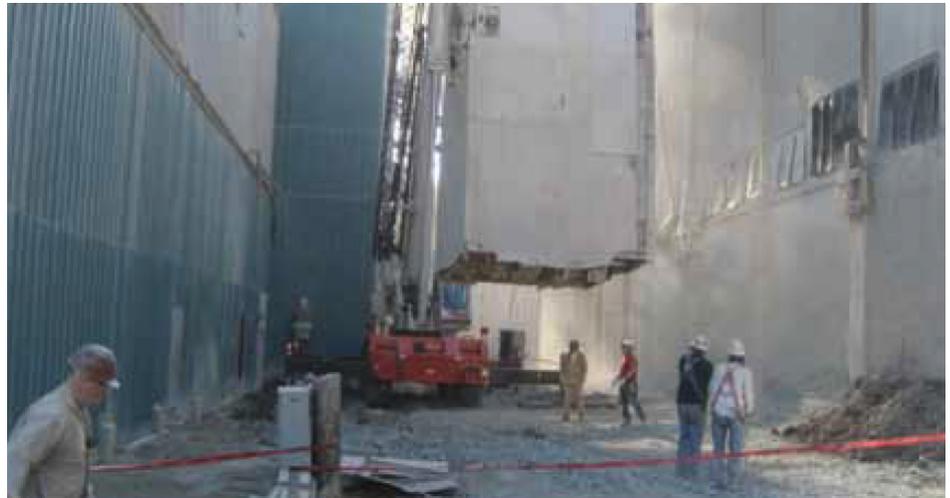
Figure 1: the tight access made the removal of individual compartments difficult.

The only options for the kiln system were to either completely replace the collector with a new unit, or replace the compartments from the hopper upwards. Installing a new unit was out of the question because of the downtime it would require and the substantially higher cost. It was determined that the collector would have to be repaired without disrupting the plant's production schedule. This meant replacing compartments one at a time while the collector remained in operation.

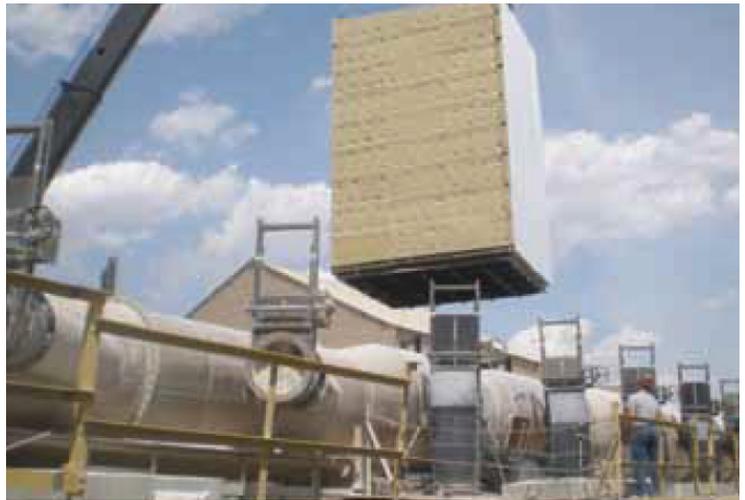
**Figure 2:** difficult crane access required 'flying' half of the compartments over the on-line system. Careful planning and close co-ordination were required to assure the compartment change-outs went smoothly

Logistics proved to be the most difficult aspect of the overall project. Online equipment modifications require significant planning and coordination of the manufacture and shipment of the equipment, or else there would be breaks in the workflow. The lay down area was small and allowed only one new compartment at a time to be received and worked on. There was very little room to unload the equipment and leave available room for the insulation crews to do their work. At the same time, room was required for the demolition of the existing compartments. The kiln unit was in a relatively long narrow area that allowed crane access from only one side of the 16-compartment system. To remove and install seven of the 14 compartments, the crew had to lift the replacement modules over the operating equipment.

Difficult crane access required 'flying' half of the compartments over the on-line system. Careful planning and close co-ordination were required to assure the compartment change-outs went smoothly.
