US manufacturer of Pig feed was able to eliminate dusty work environment and reduce maintenance clean-up times

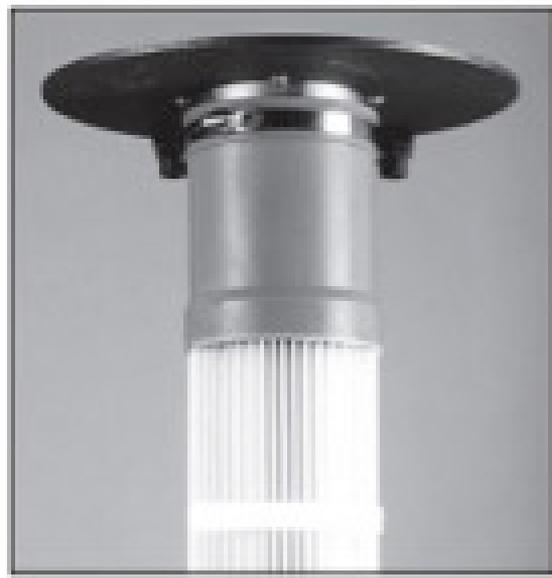
The urethane tops on the shorter BHA PulsePleat BA140 filter elements allow for an easy, leak-free installation, increase cloth area, allow customers to capture more of their valuable product, and shorten maintenance clean-up time & installation.

After consulting with CLARCOR Industrial Air solutions experts, it was recommended the customer install 25, 1-meter BA140 BHA® PulsePleat® filter elements with spunbond polyester. The soft polyurethane top allowed for a squidgy-fit making an easy leak-free installation.
